***Hurricane Barrier Inspection Report
New London, CT***

**Re: New London Shaw Cove Hurricane Barrier Inspection
Job # DR31011**

**RE: Final Report for Cathodic Protection Compliance Testing, Inspection and Evaluation of Approximately 250 Linear Feet of Steel Sheet Pile Wall In New London, CT.
Acuren P.O. No.: Verbal Authorization as per Mr. Ted Lund
CorrTech, Inc. Job No. 6654**

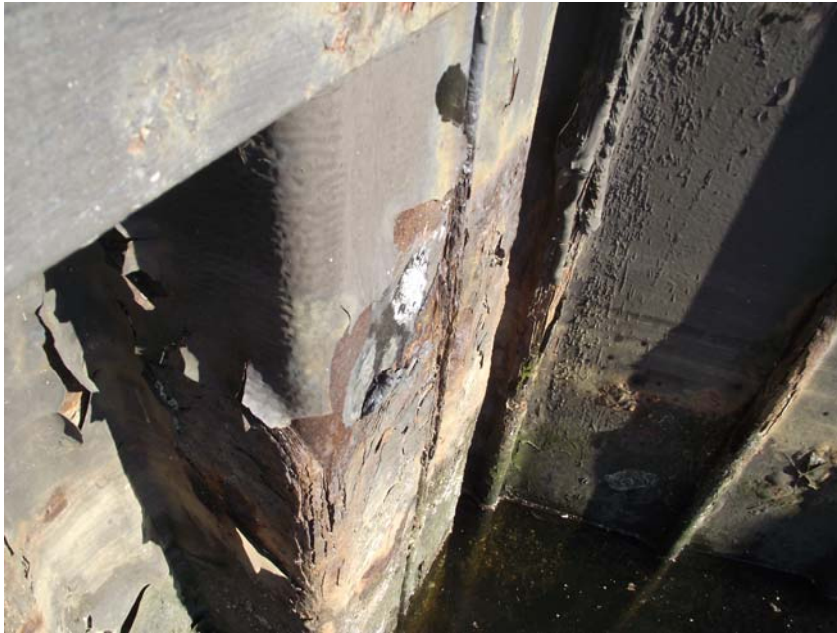
Typical tidal zone metal loss

The steel sheeting has widespread failure of the asphaltic coating on the water side. The steel has extensive, deep layer corrosion in the sheeting seams and on the corners. Thick layer corrosion has developed and has resulted in 20-50% metal loss on the water side.

The exposed sheeting should be abrasive blasted and hammered to remove the surface corrosion and layered steel. The thin areas should be reinforced with ½-inch plate welded on the exterior. All of the sheeting above the low tide level should be coated with a splash zone quick cure catalyzed coating.

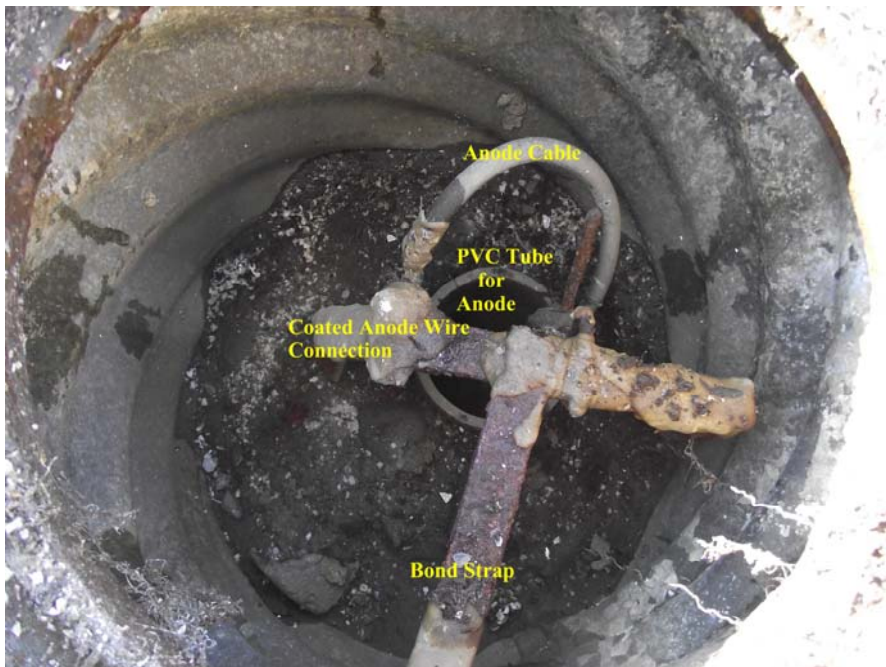
Typical CP Station

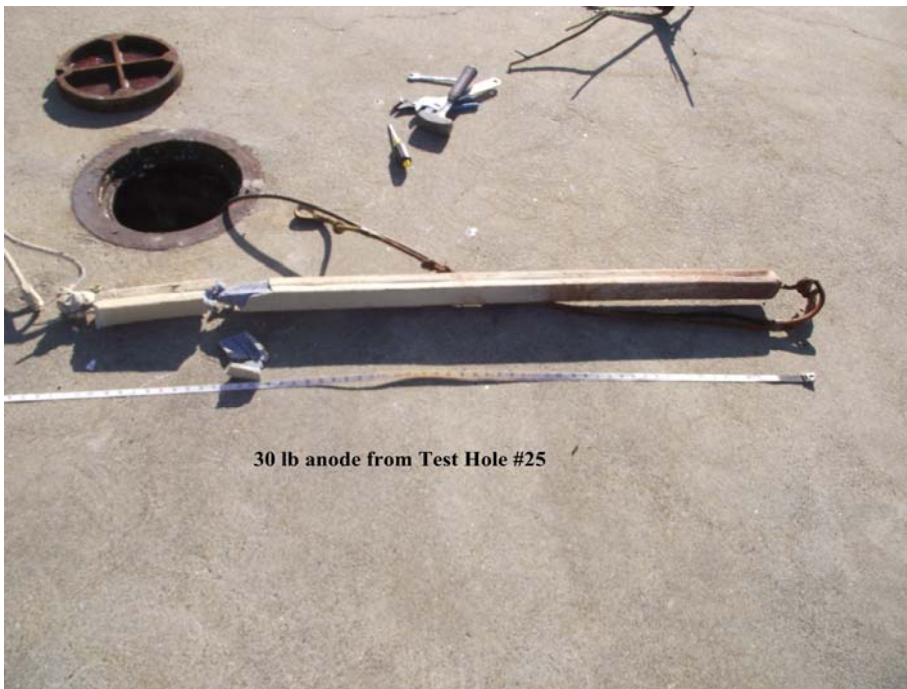
CP#25

3. Anode No. 25 was pulled for inspection. The anode is depleted and will no longer function.
4. Analysis of the data obtained for the land-side cathodic protection indicates that the anodes tested are marginally effective, with the exception of anode No.25. It is not known the length of time the anodes have been operating. It is not known if any of the anodes have been replaced.
5. Water-side test station testing was limited to “on” potentials only as the connections are thermite welded to the sheet pile wall. Water side test stations were designated “A” through “L” for clarity. “On” potential readings were measured and found to be:

Without past historical test results for comparison and date of installation and/or replacement records, it is concluded that the land-side zinc anodes are marginally functional at this time. Anode No. 25 was pulled for inspection and clearly indicated that the zinc anode was depleted as over 75% of its original weight has been lost. This anode is obviously non-functional and should be replaced. Several of the land-side anode locations could not be pulled for inspection as they are stuck in silt and debris. It is additionally considered that all land-side zinc anodes should be replaced with high potential magnesium rod anodes. This may present a problem with installation as a majority of the perforated PVC tubes that house the anodes have become filled with sediment and debris. This may necessitate the re-auguring and/or vacuuming of the PVC tube to allow for the installation of new anode material. Many of the hand-hole mechanical connections are badly corroded and would require replacement as well.

1. Consideration should be given for the replacement of the land-side zinc anodes. Magnesium rod anodes are recommended.
2. Consideration should be given for the replacement of the water-side zinc anodes. Aluminum hull anodes are recommended.
3. Upon notice to proceed, CorrTech, Inc. would present design calculations and installation recommendations for the above referenced sacrificial cathodic protection systems.

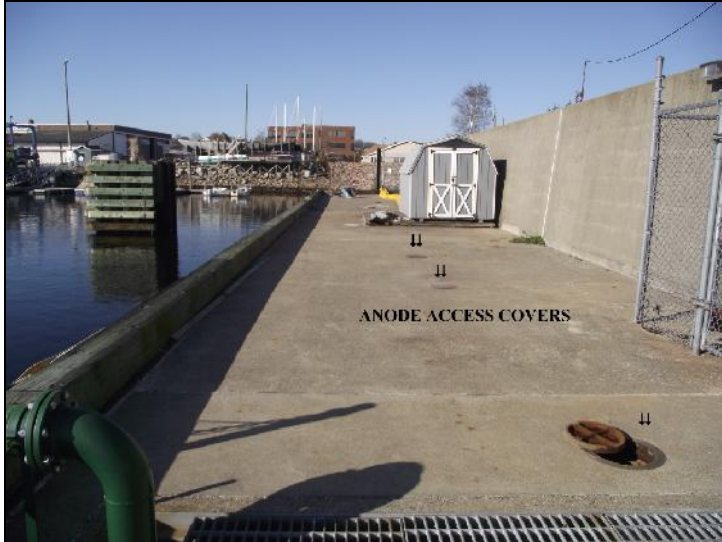
DP#1

West end of dock and sheet pile

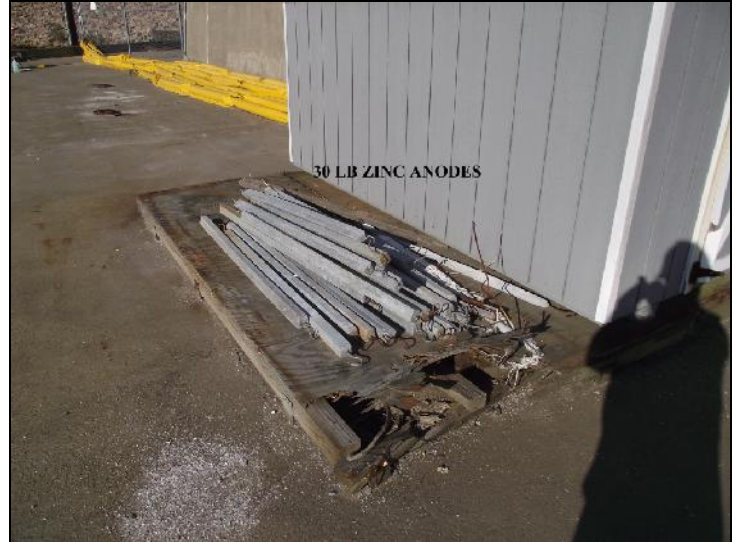
DP#2

Unused zinc anodes for replacement

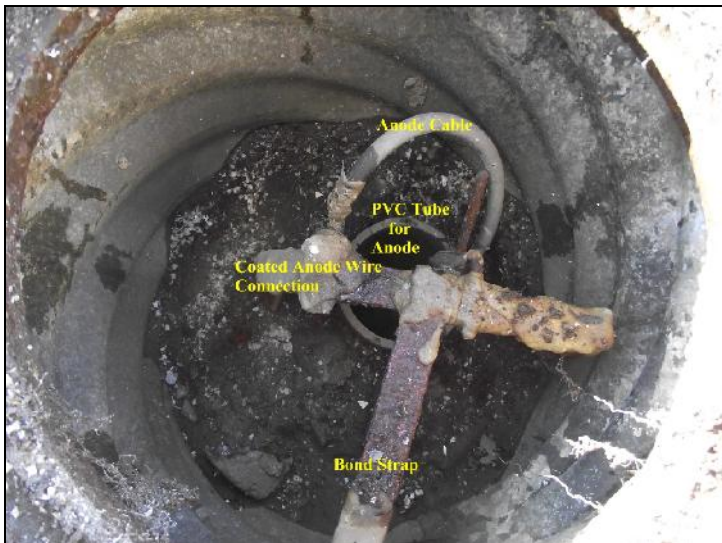
DP#3

Typical soil side anode installation

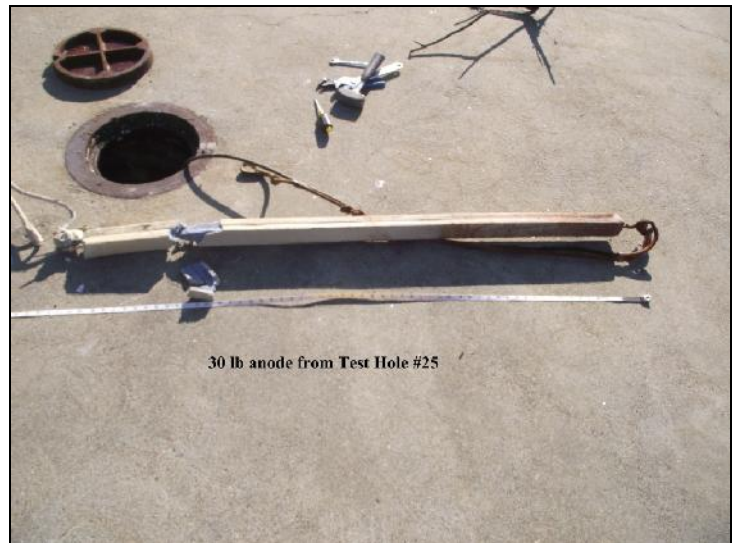
DP#4

Zinc anode pulled from station 25

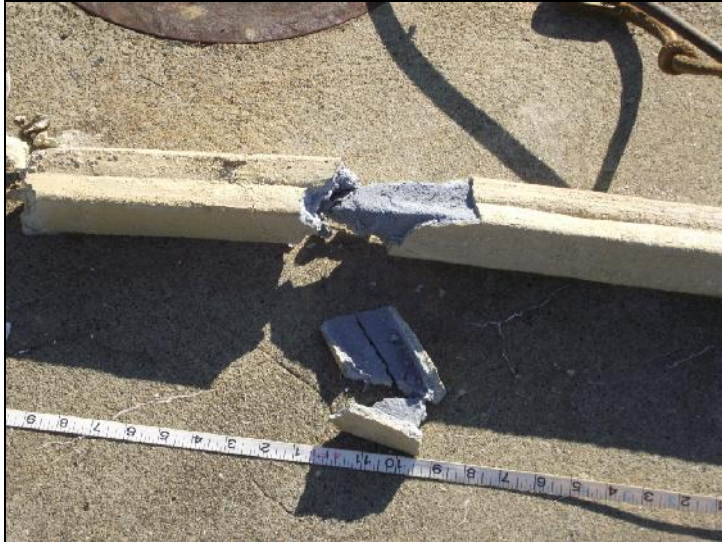
DP#5

Close-up of anode, shows deterioration of zinc

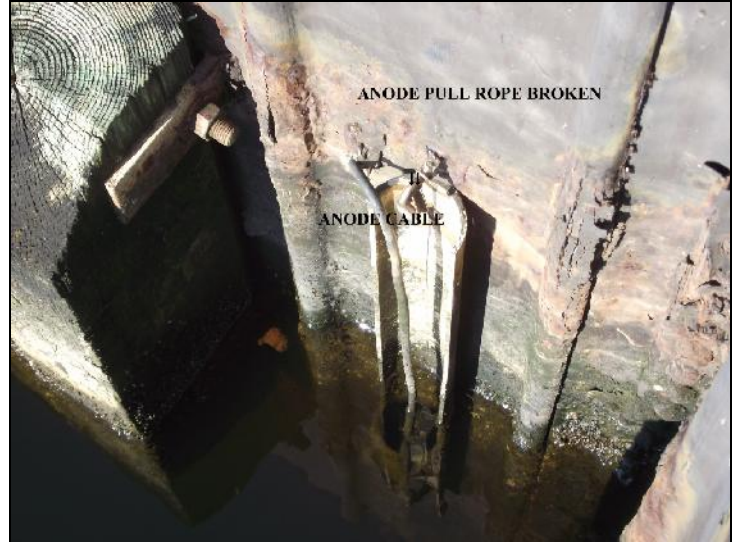
DP#6

Typical water side anode installation

The water-side zinc anodes appear to be non-functional. Because of the location and direct attachment to the wall, these anodes were not pulled for inspection. A potential profile was performed and shows that the "protected on" values measured ranged from 0.616 volts to 0.649 volts. These values are indicative of un-protected, static base potentials of coated steel in a salt water environment. It should be noted at this time that the use of zinc anode material in a salt water environment is not recommended. The typical anode of design in this environment is aluminum. It also appears that the amount of zinc installed was underestimated.

It is concluded at this time that the water-side zinc anodes should be replaced with aluminum hull anodes. A preliminary "estimate" is thirty (30) 96-pound anodes would be required. These anodes are manufactured with a steel core that is off-set. Under water welding would be required.

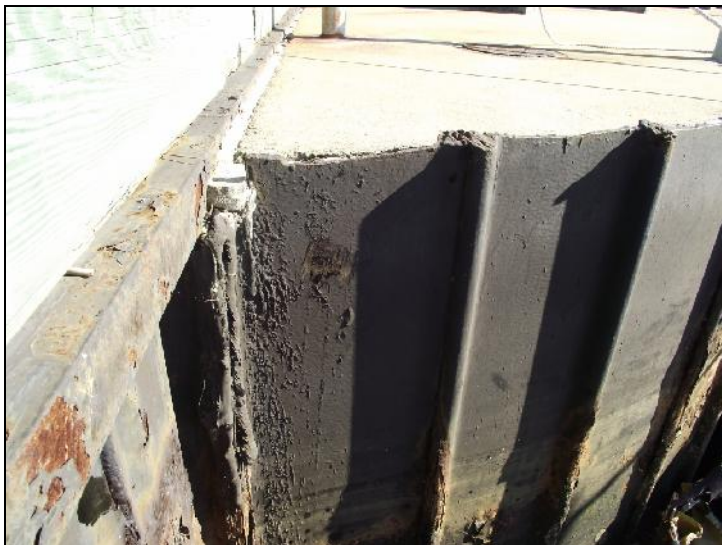
DP#7

Typical sheet pile condition at top

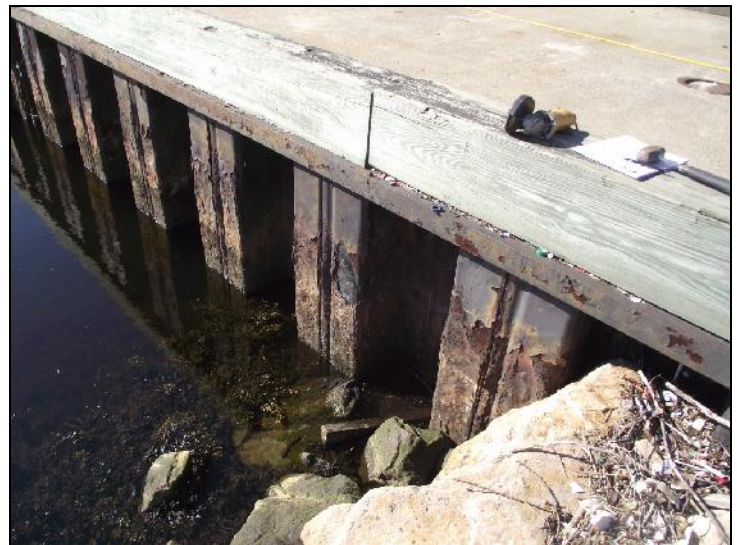
DP#8

East end of sheeting, tidal zone corrosion is apparent

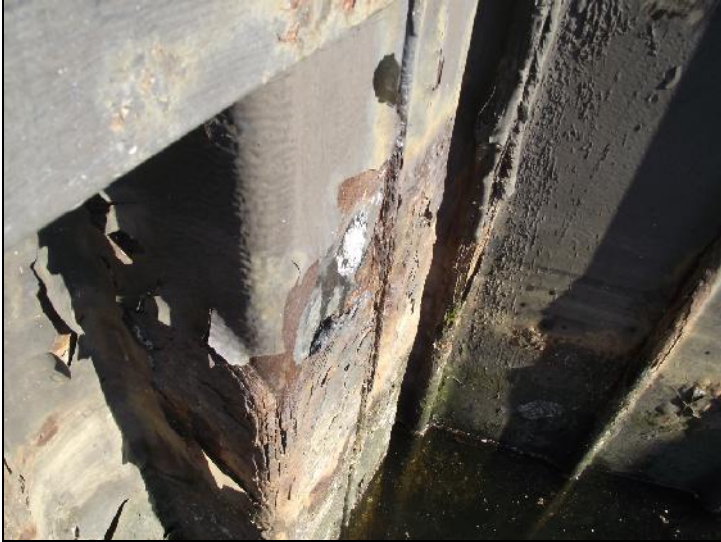
DP#9

Typical severe corrosion and layering in tidal zone

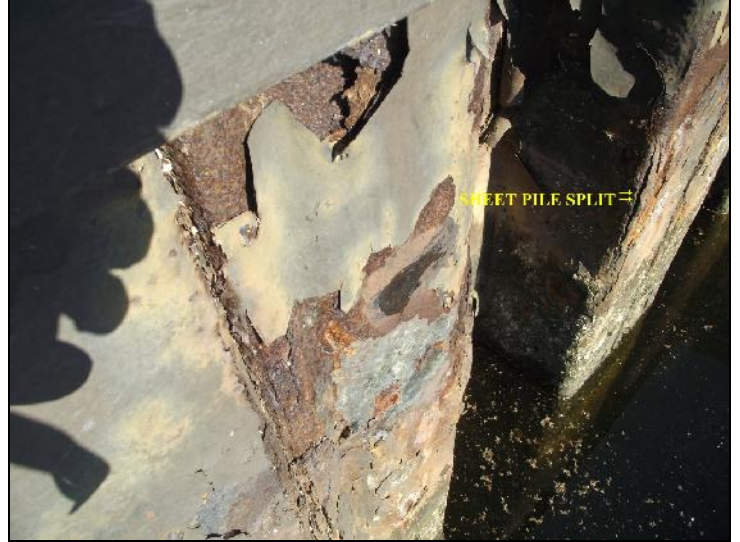
DP#10

Deep layer corrosion and splitting on corner bend of sheet

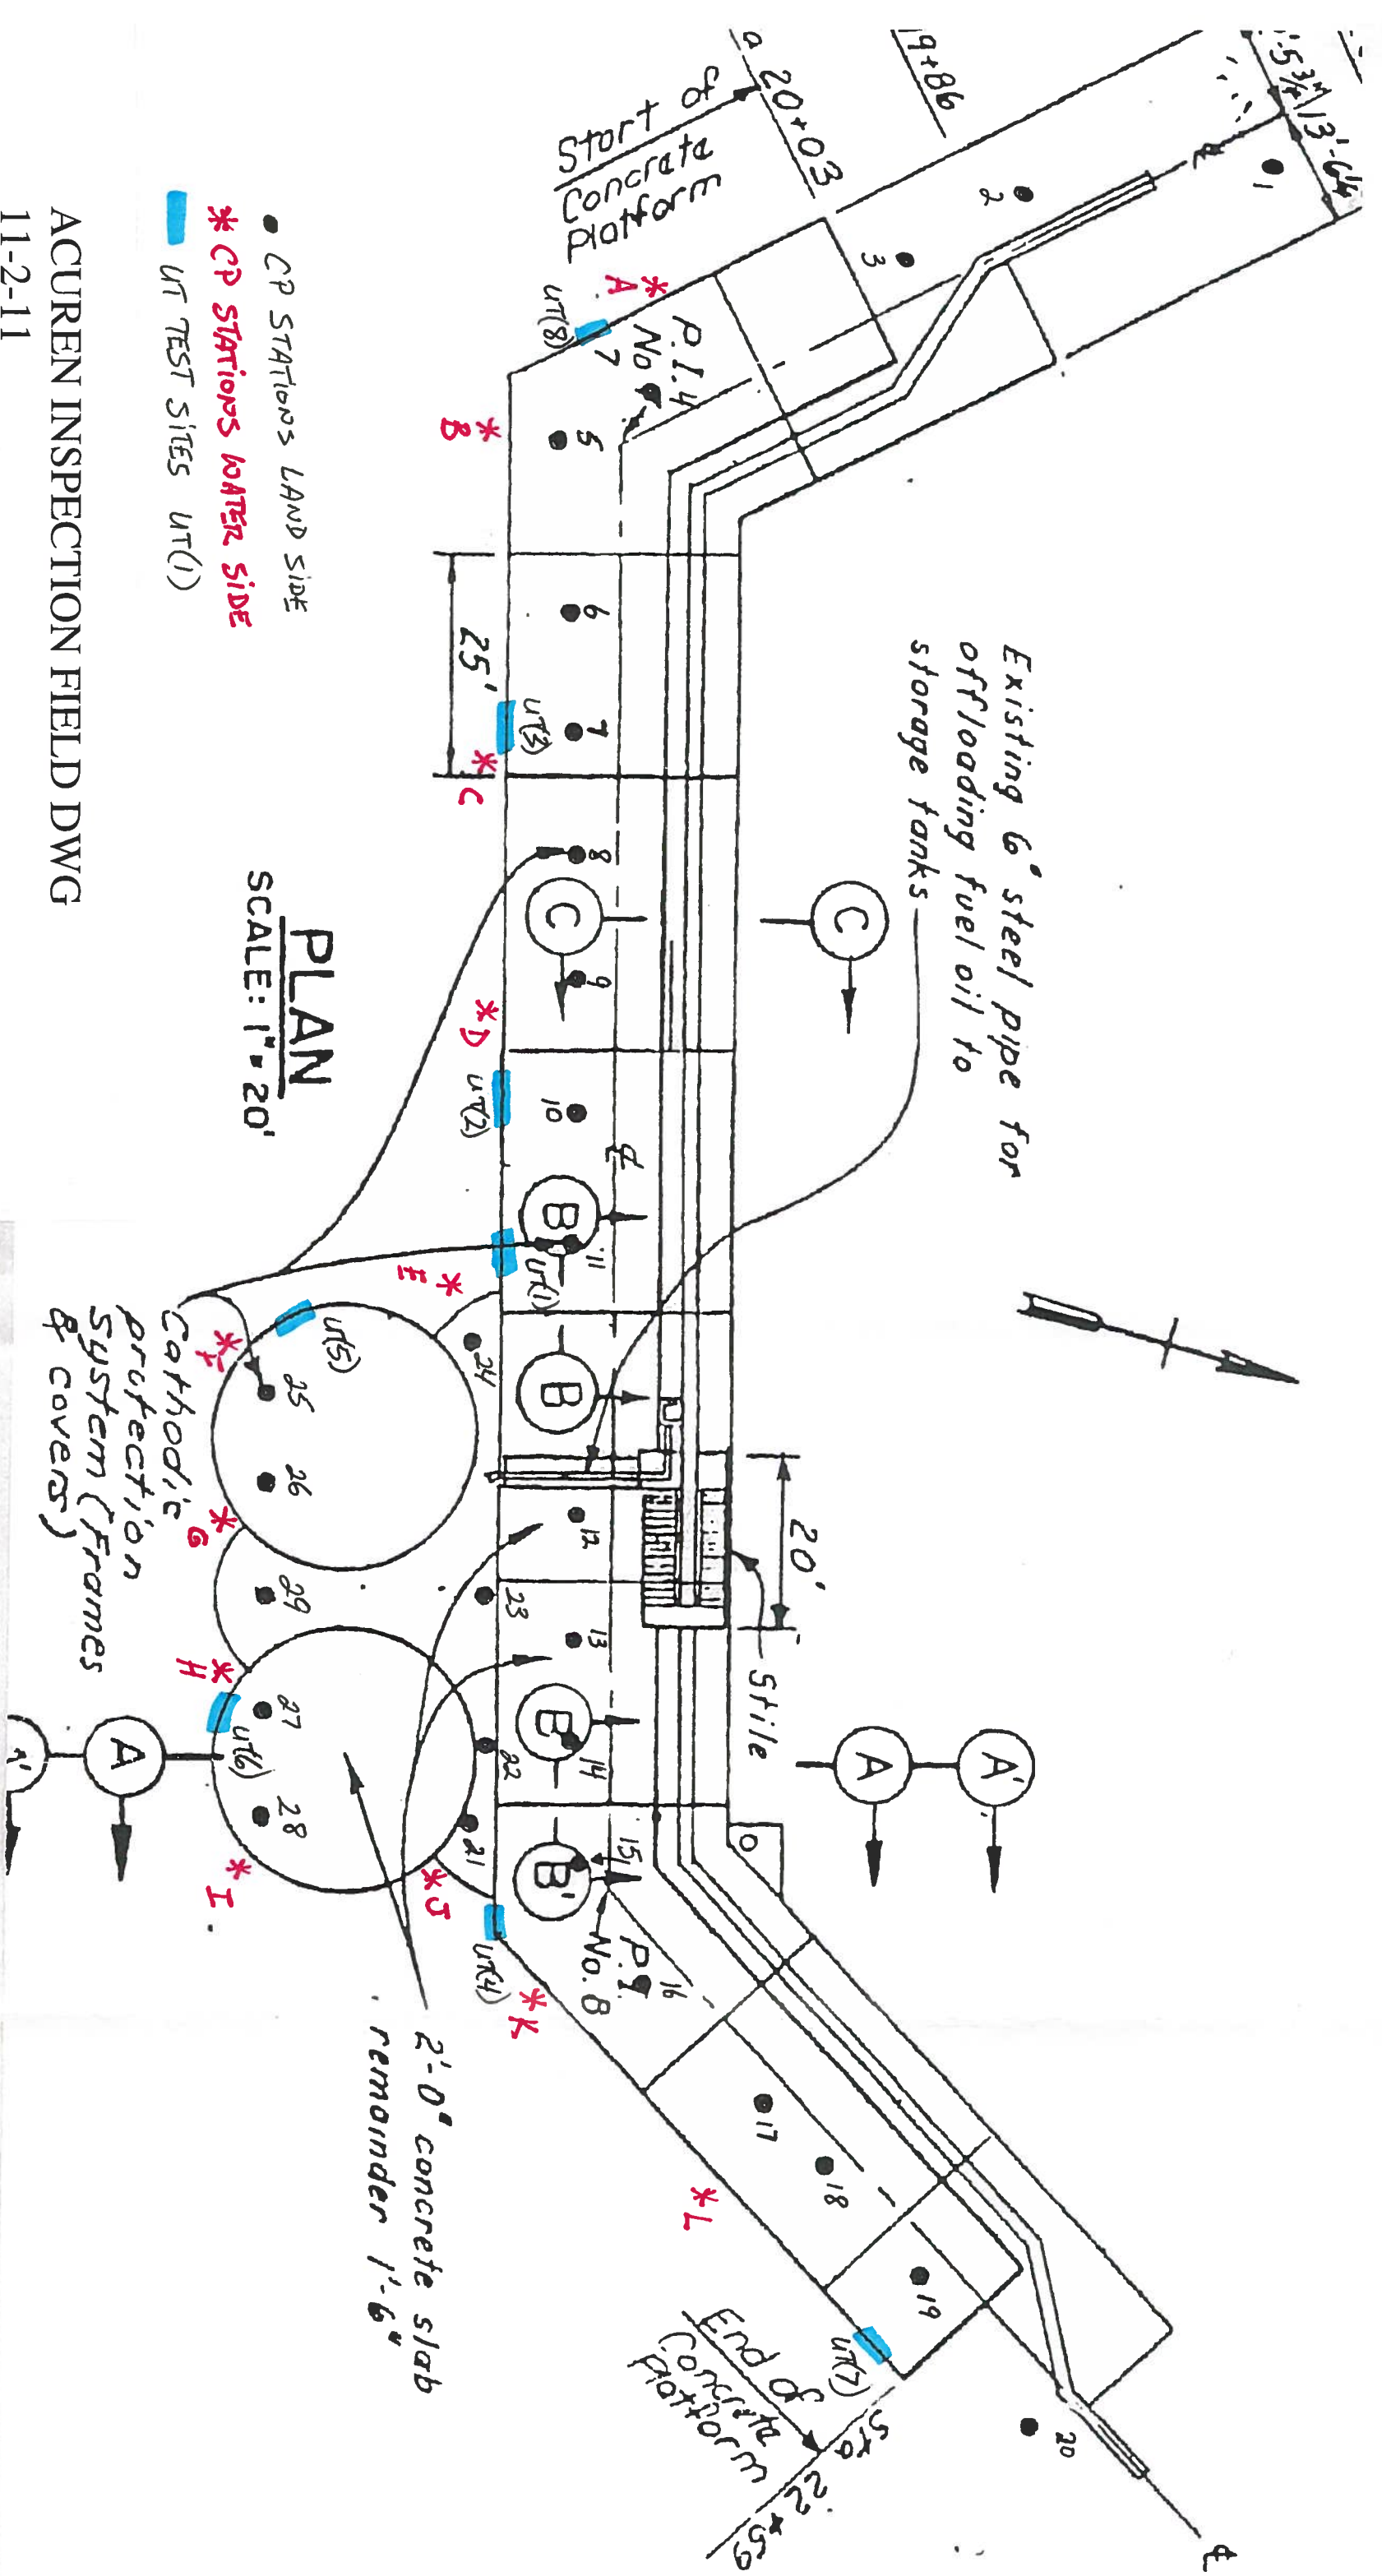
ACUREN INSPECTION FIELD DWG
11-2-11
NEW LONDON HURRICANE BARRIER STUDY
SHAW COVE, NEW LONDON

Eight (8) locations were scraped, hammered and power tool cleaned to remove the corrosion scale and coating. A 5Mhz transducer was used to scan the prepared areas to record the maximum and minimum values. The eight locations are shown on the attached dock diagram. In the thinnest areas a hammer test clearly showed the remaining plate to be a fraction of the original thickness, evident by the flex in the plate.

Location	Max	Min
UT1	.500	.380
UT2	.500	.385
UT3	.380	.135
UT4	.440	.170
UT5	.375	.125
UT6	.380	.245
UT7	.450	.120
UT8	.480	.135

<u>Test Station (as shown on dwg)</u>	<u>Comment</u>
4	potential test
5	potential test
6	potential test
11	potential test
14	detached for current potential
16	detached for current potential
25	pulled and photographed
26	potential test
27	detached for current potential
28	potential test
B	potential test
C	potential test
E	potential test
G	potential test
H	potential test
J	potential test
L	potential test
